**Evaluation of the  
Gilbert Demonstration**

Bowman & Brooke, LLP  
1741 Technology Drive, Suite 200  
San Jose, CA 95110

*Attorneys for*  
Toyota Motor Corporation and  
Toyota Motor Sales, USA, Inc.

March 2010

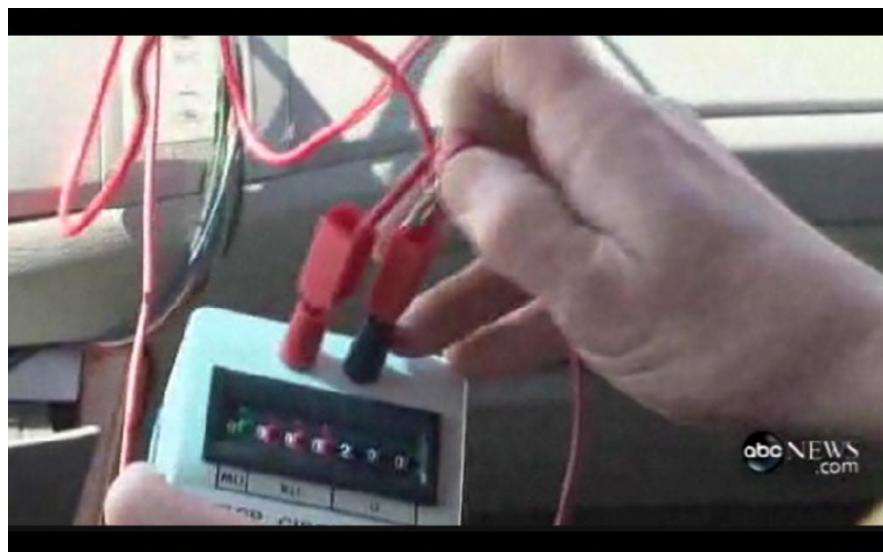
Figure 1. A 200-ohm resistance is apparently connected between the output signals of the two pedal position sensors. A third wire is about to be inserted into one side of the resistance.

The two independent accelerator pedal position sensors produce different output voltages that are fed to the ECM of the vehicle, and are used by the ECM to compute a throttle setting and to assess whether the pedal signals are valid. Figure 1 also shows Dr. Gilbert holding a wire that he then connected to one side of the 200-ohm resistor.<sup>3</sup> The other side of the wire was apparently connected to the 5-volt power supply for one of the pedal’s sensors.<sup>3</sup> These manipulations changed the signals that were coming from the pedal, feeding higher voltages to

Dr. Gilbert intentionally created two sequential faults. The first fault required that the insulation be mechanically defeated on the wires carrying the two pedal position sensor outputs, and then required connecting these two wires with a carefully chosen resistor. The second fault required that more insulation be mechanically defeated on a power supply wire and then formed a low resistance connection between this wire and the output of pedal position sensor #2. These faults must be mechanically created in the prescribed sequence and with strict limits on the value of the resistance between the insulation defeats to avoid detection by the ECM. This will be discussed more fully in a later section.

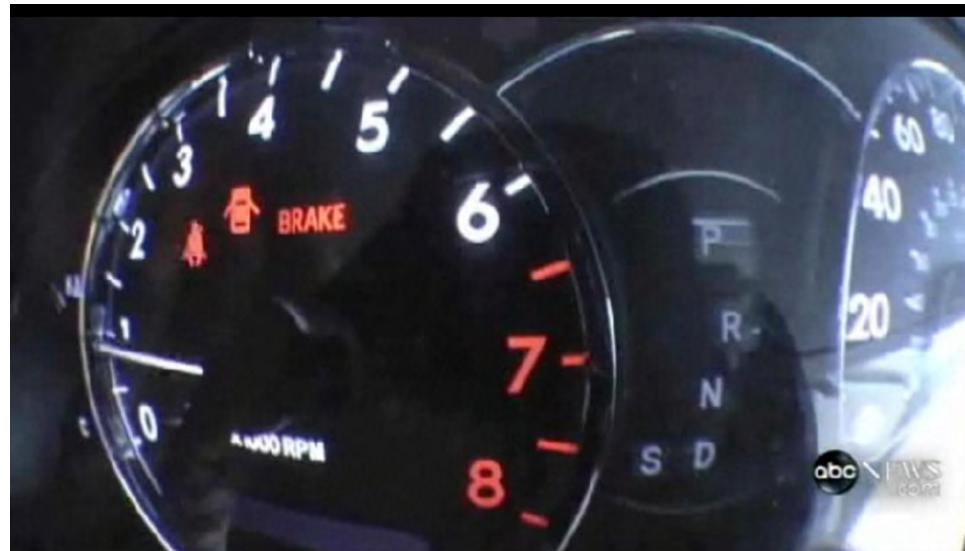
was not filmed while the vehicle was moving (as implied in the ABC News video), but rather while the vehicle was parked. If the vehicle had been driven, the engine could not have responded as rapidly to the external faults created by Dr. Gilbert as shown in the video. This deliberate manipulation of chronology was not disclosed to ABC viewers.

Figure 2. Idle speed condition of the vehicle prior to connecting the power supply to the resistor, ABC video at 2:15.

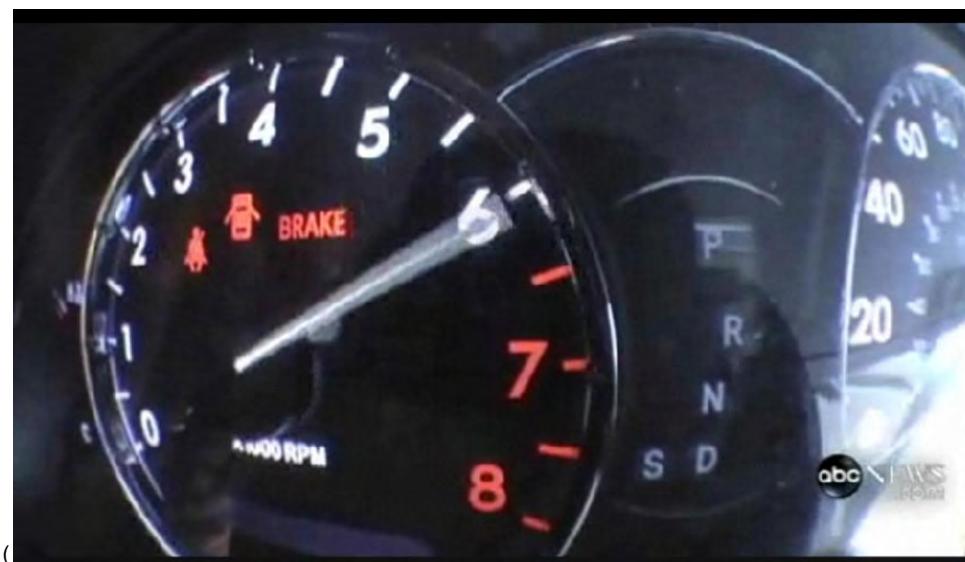
Figure 3. High engine speed resulting from signal manipulations, ABC Video at 2:15.

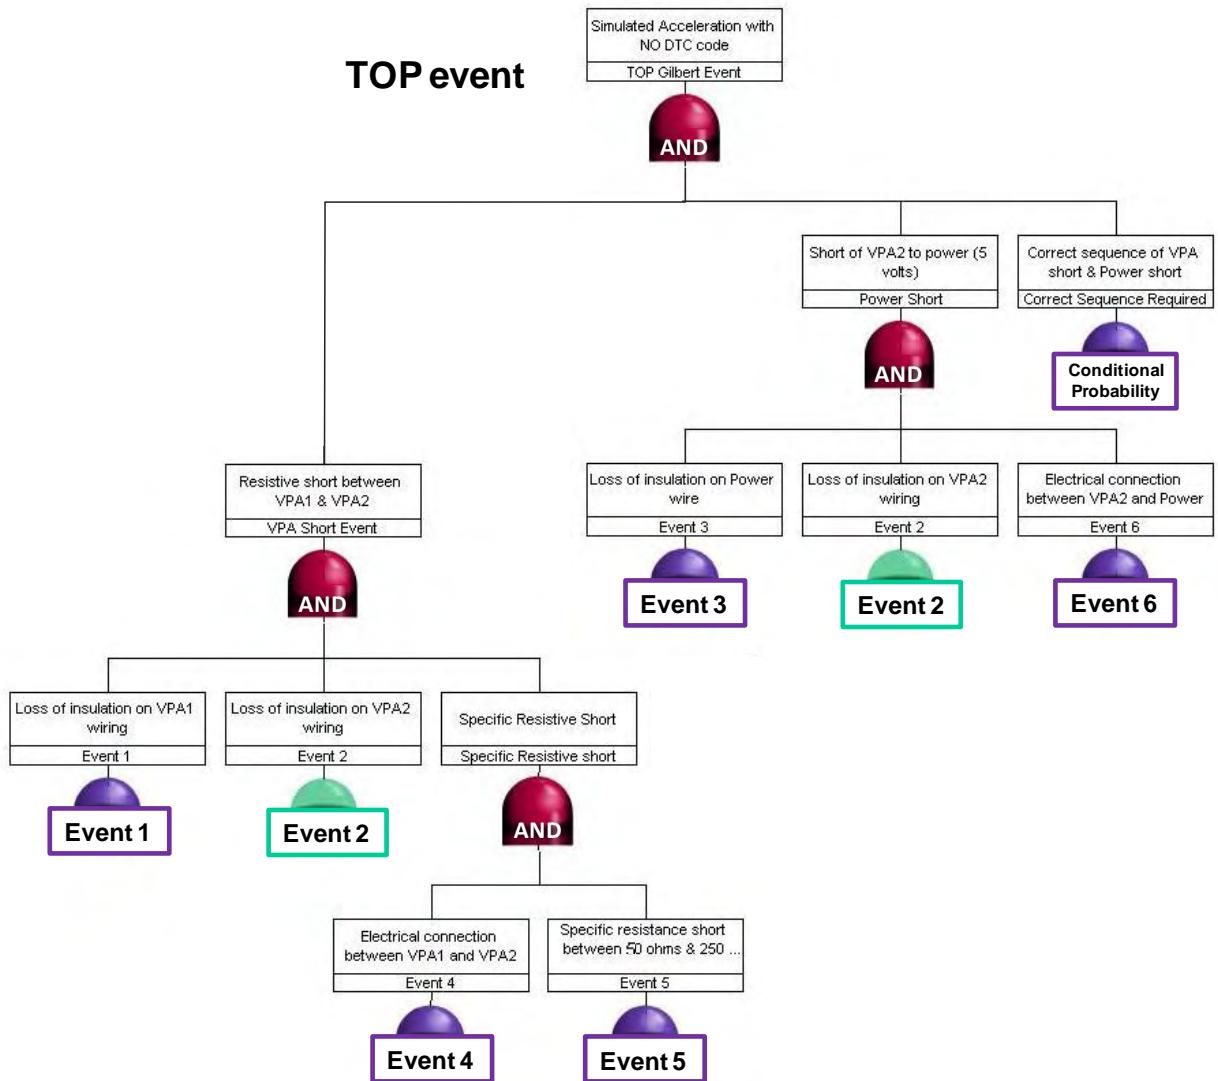
Our analysis illustrates that Dr. Gilbert's scenario requires a complex combination of multiple faults or failures, and that these faults must occur in a precise sequence to produce the "Top" failure event, namely an unintended engine revving with no DTC. These fault events and conditional probabilities are identified as follows:

Figure 5. Fault tree analysis for Gilbert demonstration (Avalon).

In fault tree analyses, scenarios or “TOP” events requiring three or more independent fault events are not considered as dominant contributors because the likelihood of occurrence of three or more independent fault events is remote. In Dr. Gilbert’s demonstration, six fault events and an additional conditional probability (due to the constraint of a specific event sequence) are required (Figure 5). Even under conservative assumptions that take into consideration the possibility of common cause events, at least three independent fault events are required to cause engine revving in the field using the concept on which Dr. Gilbert’s protocol is based.

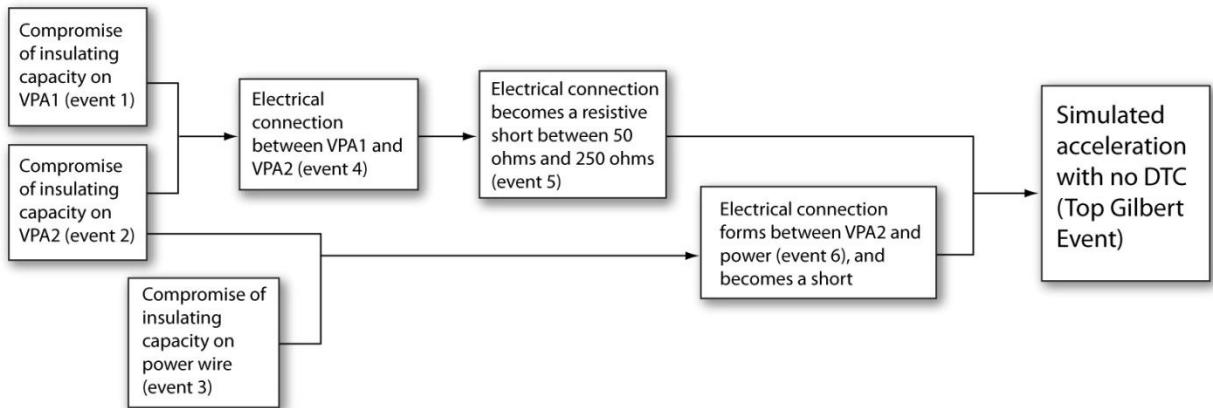
Figure 6. Flowchart of events for Gilbert demonstration (Avalon).

Dr. Gilbert's protocol would not cause engine revving unless the electrical faults he intentionally introduced occur in a specific sequence. For example, if VPA2 and VCP1 (or VCP2) were electrically connected before the VPA1-to-VPA2 fault was reliably formed, or did not possess the appropriate resistance characteristics (Figure 7) a DTC would be set, and the engine would enter a fail-safe mode of operation.

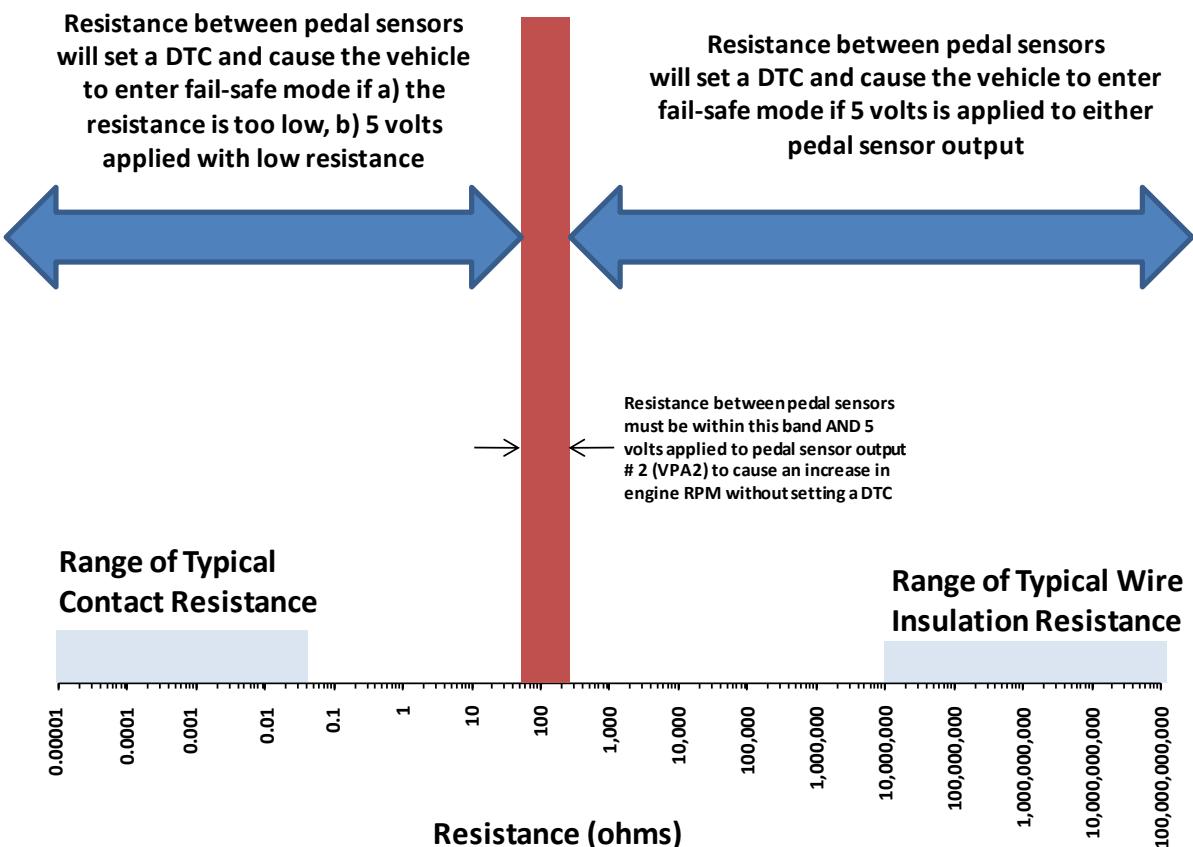
Exponent has performed testing and analysis to determine the range of electrical resistances for the 2010 Avalon that would result in the simulated acceleration. It was determined that the necessary resistance must be between approximately 50 and 250 ohms. Resistances outside this range may result in a DTC. Figure 7 summarizes this finding and illustrates the narrow range of resistances to which Dr. Gilbert's demonstration is confined. It is highly unlikely that a fault could be created under real world conditions that would land in this narrow band of electrical resistances (and stay there) without setting a DTC.

Figure 7. Effect of different resistances placed between pedal sensor wire outputs (VPA1 and VPA2).

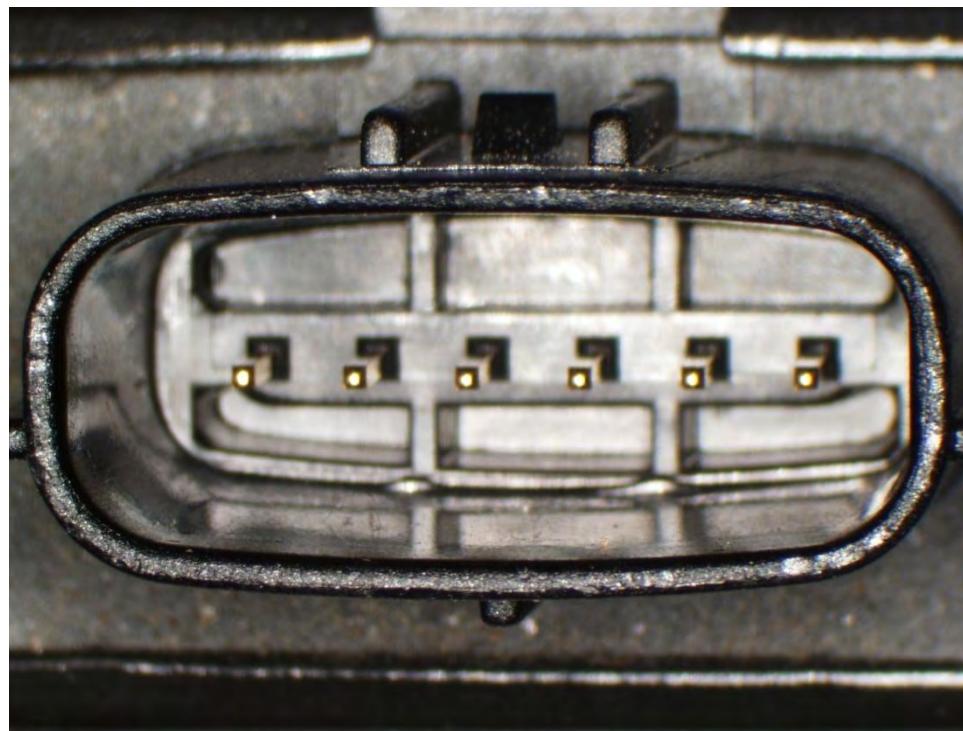
The pedal assembly male connector (shown in Figure A1) is a molded part attached to the pedal assembly. It has the following characteristics:

- Plastic shell surrounds pins of connector protecting them against direct moisture contact
- Connector pins are located on raised pedestal.
- Connector shell has locking mechanism that interlocks the two-connector portions to prevent connector separation and maintain a seal.

Figure A1. Male portion of connector.

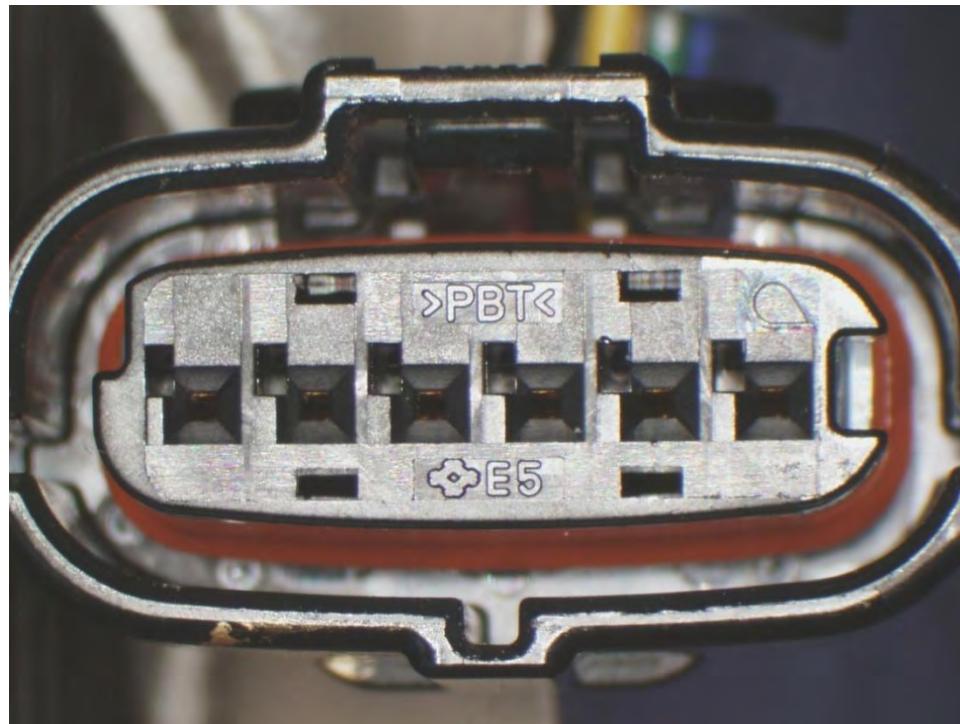
The cord-mounted female connector (shown in Figures A2 and A3) has the following characteristics:

- Plastic shell surrounds housing of male portion to prevent direct moisture contact.
- Rubber gasket surrounds rim of female portion making connector waterproof.
- Each pin fits into its own insulated slot to electrically isolate pins from each other.
- Recessed pin sockets reduce the possibility of adjacent pin electrical interconnection on the female side of the connector.
- Plastic divider extends into the connector further reducing the possibility of adjacent pin electrical interconnection.
- Connector wires are individually insulated.
- Wires are individually sealed with separate cylindrical grommets
- Wires are spaced to prevent adjacent wire contact.

Figure A2. Plastic connector shell surrounds inner connector pedestal to house female sockets. Rubber gasket helps make the connector waterproof. Recessed pins and insulating divider between pins electrically isolates adjacent sockets.

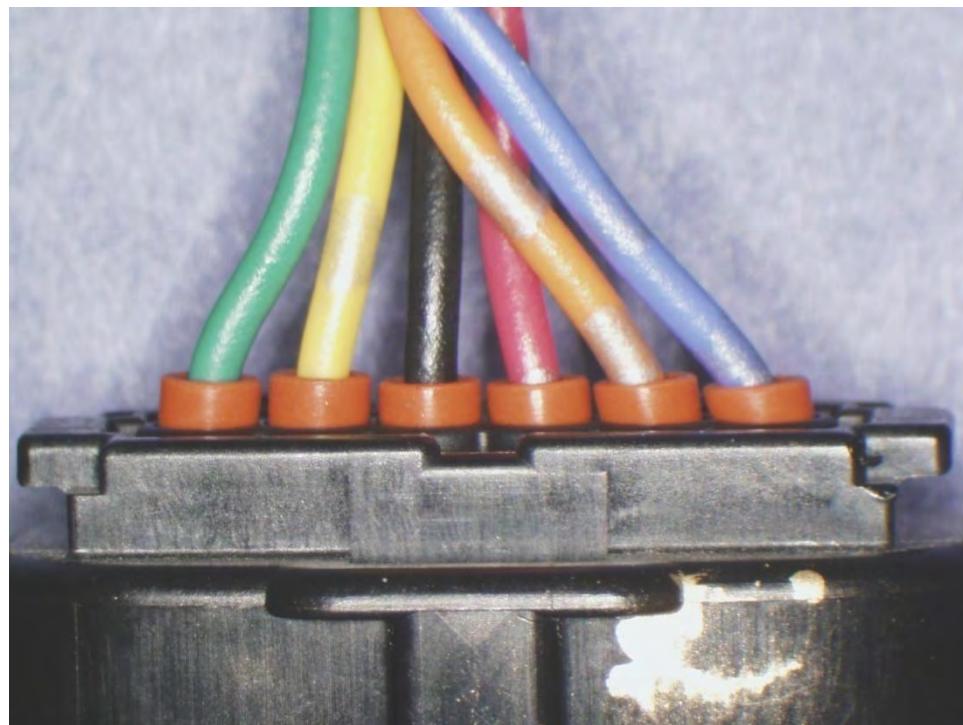
Figure A3. Each connector lead is insulated and protected by a polymeric grommet that helps make the connector waterproof and provides another layer of electrical isolation between sockets.
