**Evaluation of the  
Gilbert Demonstration**

Bowman & Brooke, LLP  
1741 Technology Drive, Suite 200  
San Jose, CA 95110

*Attorneys for*  
Toyota Motor Corporation and  
Toyota Motor Sales, USA, Inc.

March 2010

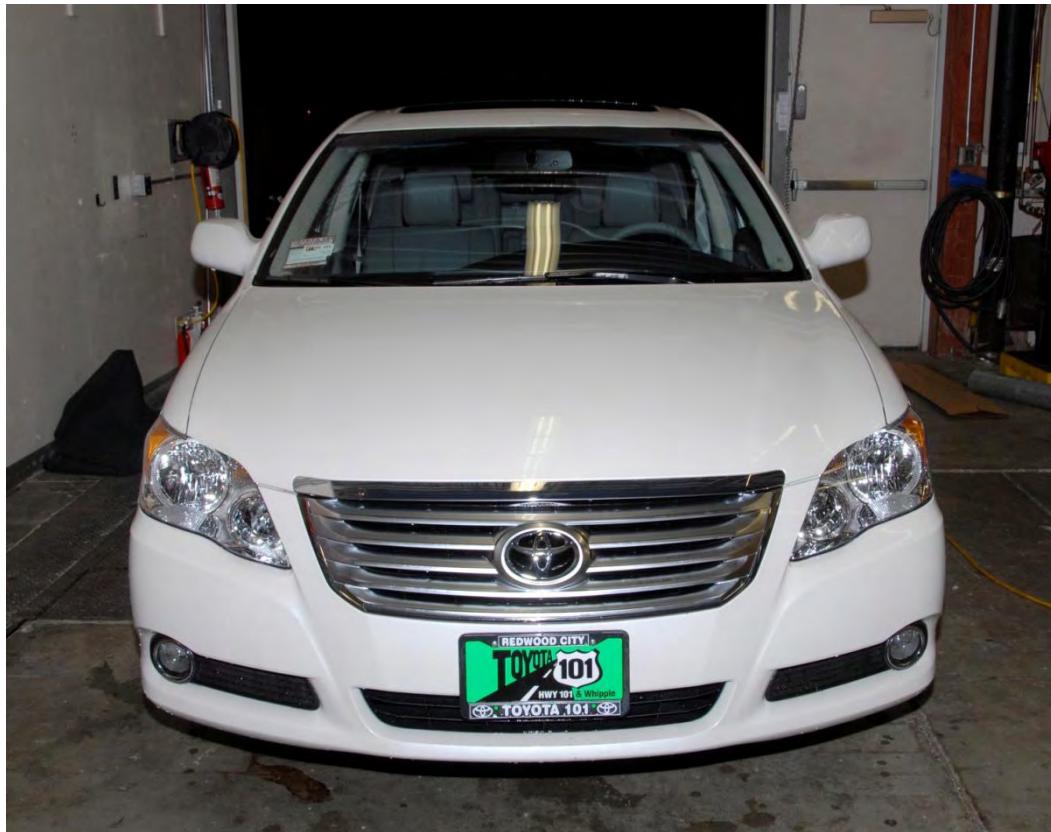
Figure 4. Tested 2010 Toyota Avalon.

Exponent recreated Dr. Gilbert's demonstration using the 2010 Avalon shown in Figure 4.<sup>5</sup> This involved precise mechanical creation of two sequential wiring faults. Exponent inserted a set of jumper wires between the pedal assembly and the wiring harness connector to the pedal. The jumper wires enabled electrical interconnections between the wires that carry power and pedal position signals between the accelerator pedal and the ECM. The two wires that carry the pedal position signals from the accelerator pedal to the ECM were electrically connected through a 200-ohm resistance. Adding the resistance did not noticeably change the operation of the engine, though increasing or decreasing this resistance more than a limited amount would set a DTC (immediately if the resistance was too low, or later when the second fault was created.) To cause an increase in engine speed, Exponent then connected one of the 5-volt power supply wires from the accelerator pedal to the secondary accelerator pedal position signal wire (VPA2) using another jumper wire. Exponent's recreation of the Gilbert demonstration on the Avalon resulted in an apparent "sudden" onset of acceleration and engine revving, similar to that shown in Dr. Gilbert's demonstration. The apparent "sudden" onset of the acceleration was due to artificially creating the second fault in an instantaneous manner after the carefully engineered first fault.

circuit manipulation in an operating vehicle, the physical presence of such faults would unquestionably leave “fingerprints,” as discussed later.

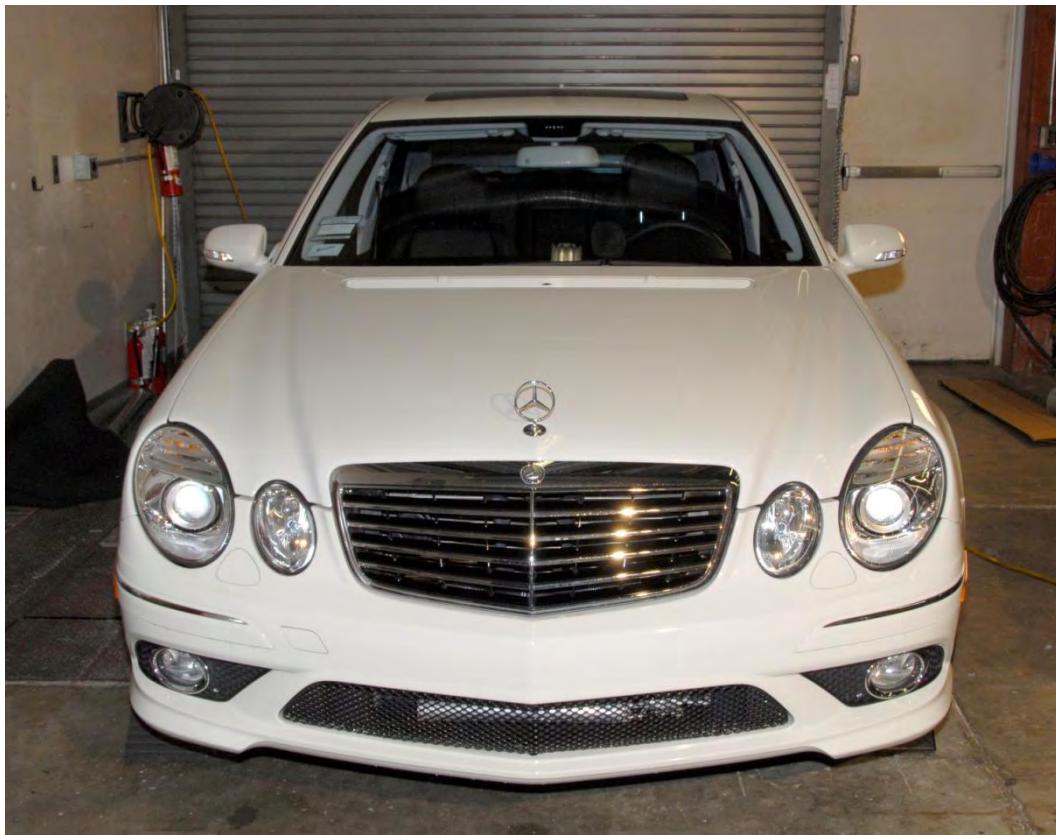
Figure 8. Tested 2009 Mercedes E350.

Dr. Gilbert's fault creation protocol was applied to the 2009 Mercedes E350 shown in Figure 8.<sup>10</sup> As with the Avalon and Camry, this involved mechanically creating two sequential electrical faults. Exponent inserted a set of jumper wires between the pedal assembly and the wiring harness connector to the pedal. The jumper wires enabled electrical interconnections between the wires that carry power and position signals between the accelerator pedal and the ECM. Using these jumper wires, the two pedal sensor output wires were connected through a 200-ohm resistor. The resistance value was identical to that used by Dr. Gilbert when he tested his Avalon. To cause an increase in engine speed, Exponent connected a 5-volt power supply wire to the accelerator pedal through a second resistor of 100 ohms.<sup>11</sup> The demonstration on the 2009 Mercedes E350 resulted in an apparent "sudden" onset of acceleration and engine revving, similar to that shown in Dr. Gilbert's demonstration. The apparent "sudden" onset of the acceleration was due to artificially creating the second fault in an instantaneous manner.

During the demonstration, the check engine light did not illuminate. After the demonstration, the vehicle's computer was checked using an OBD-II tool and no diagnostic trouble codes were set. Exponent obtained the same results as those shown by Dr. Gilbert in the ABC News video but with a 2009 Mercedes E350 using his protocol. Note that this demonstration was produced under highly artificial conditions where multiple mechanically-created electrical faults, specific resistances, and power supplies were wired into the system through external means to simulate depression of the accelerator pedal. If such circuit faults were actually to occur without deliberate circuit manipulation in an operating vehicle, the presence of such faults would certainly leave "fingerprints" as to their presence.

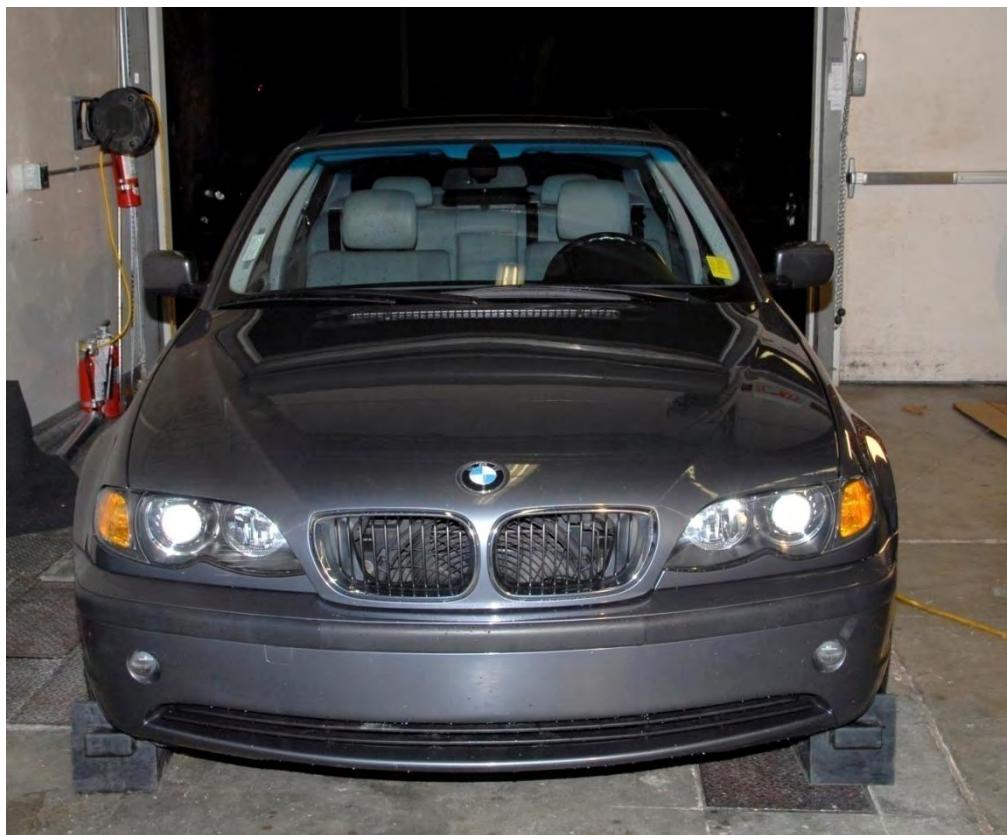
Figure 9. Tested 2003 BMW 325i.

Dr. Gilbert's fault creation protocol was applied to the 2003 BMW 325i shown in Figure 9.<sup>12</sup> As with the Avalon and Camry, this involved mechanically creating two sequential electrical faults. Exponent inserted a set of jumper wires between the pedal assembly and the wiring harness connector to the pedal. The jumper wires enabled electrical interconnections between the wires that carry power and position signals between the accelerator pedal and the ECM. Using these jumper wires, the two pedal sensor output wires were connected through a 200-ohm resistor. The resistance value was identical to that used by Dr. Gilbert when he tested his Avalon. To cause an increase in engine speed, Exponent connected a 5-volt power supply wire to the accelerator pedal through a second resistor of 100 ohms.<sup>13</sup> The demonstration on the 2003 BMW 325i resulted in an apparent "sudden" onset of acceleration and engine revving, similar to that shown in Dr. Gilbert's demonstration. The apparent "sudden" onset of the acceleration was due to artificially creating the second fault in an instantaneous manner.

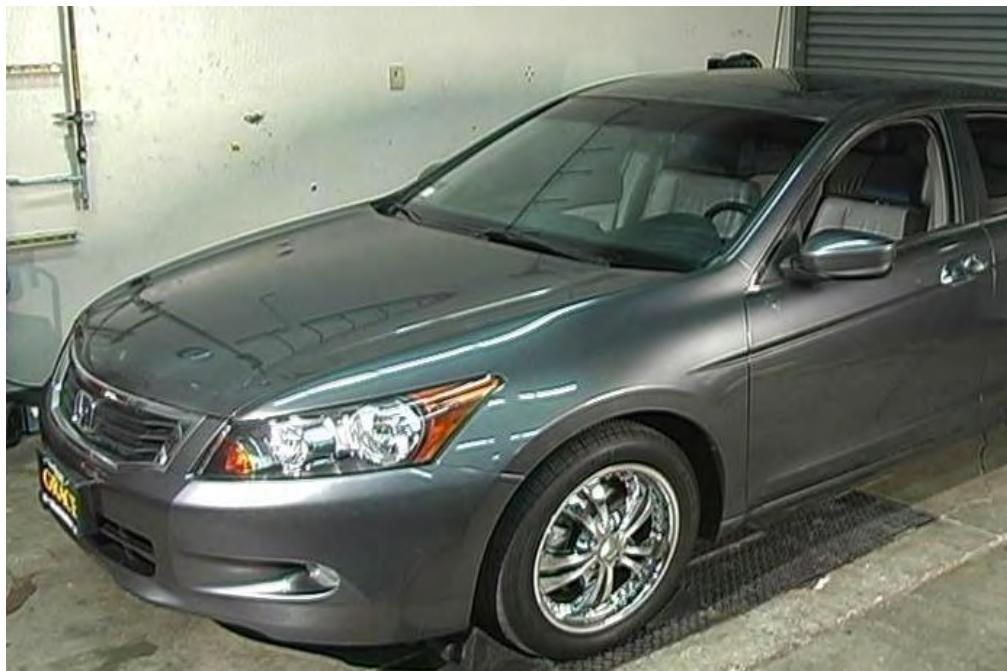
Figure 10. Tested 2008 Honda Accord.

Dr. Gilbert's protocol was applied to the 2008 Honda Accord shown in Figure 10.<sup>14</sup> As with the Avalon and Camry, this involved mechanically creating two sequential electrical faults.

second resistor of 50 ohms.<sup>15</sup> The demonstration on the 2008 Honda Accord resulted in an apparent “sudden” onset of acceleration and engine revving, similar to that shown in Dr. Gilbert’s demonstration. The apparent “sudden” onset of the acceleration was due to artificially creating the second fault in an instantaneous manner.

During the demonstration, the check engine light did not illuminate. After the demonstration, the vehicle’s computer was checked using an OBD-II tool and no diagnostic trouble codes were set. Exponent obtained the same results as those shown by Dr. Gilbert in the ABC News video but with a 2008 Honda Accord. Note that this demonstration was produced under highly artificial conditions where multiple mechanically-created electrical faults and specific resistances were wired into the system through external means to simulate depression of the accelerator pedal. If such circuit faults were to actually occur without deliberate circuit manipulation in an operating vehicle, the presence of such faults would certainly leave “fingerprints” as to their presence.

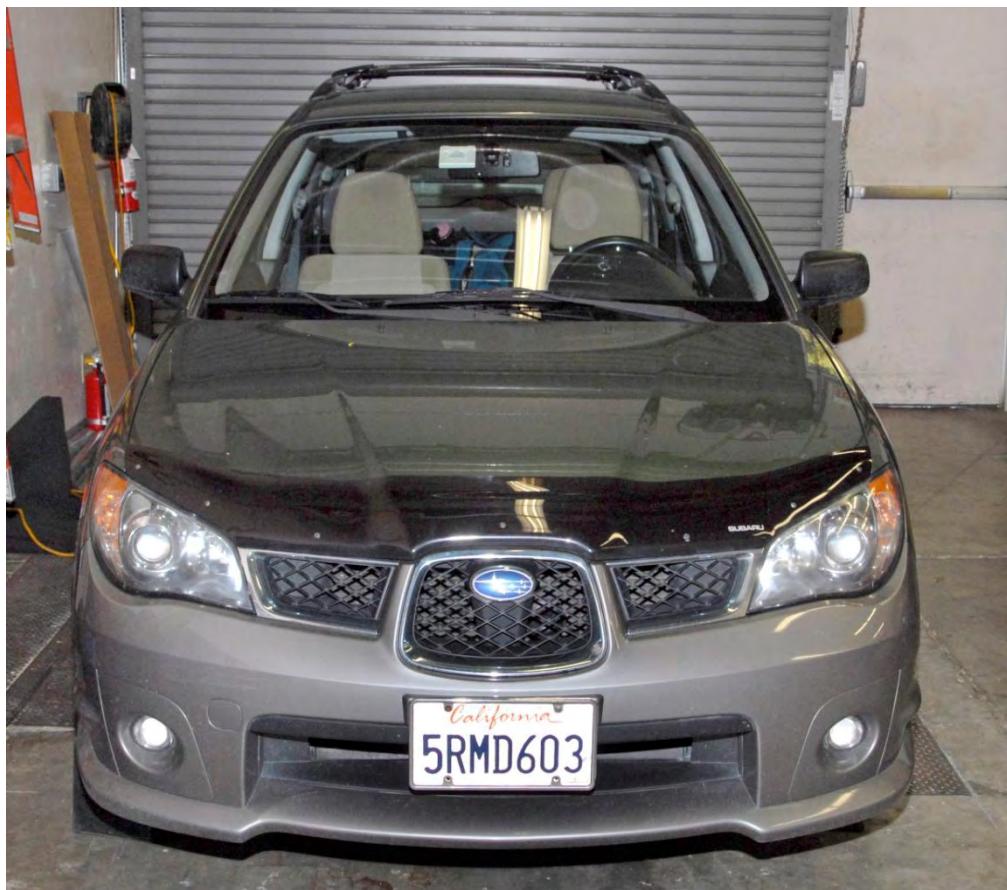
Figure 11. Tested 2006 Subaru Impreza Outback.

Dr. Gilbert's fault creation protocol was applied to the 2006 Subaru Impreza Outback shown in Figure 11.<sup>16</sup> As with the Avalon and Camry, this involved mechanically creating two sequential electrical faults. Exponent inserted a set of jumper wires between the pedal assembly and the wiring harness connector to the pedal. The jumper wires enabled electrical interconnections between the wires that carry power and position signals between the accelerator pedal and the ECM. Using these jumper wires, the two pedal sensor output wires were connected through a 100-ohm resistor. To cause an increase in engine speed, Exponent connected a 5-volt power supply wire to the accelerator pedal through a second resistor of 50 ohms.<sup>17</sup> The demonstration on the 2006 Subaru Impreza Outback resulted in an apparent "sudden" onset of acceleration and engine revving, similar to that shown in Dr. Gilbert's demonstration. The apparent "sudden" onset of the acceleration was due to artificially creating the second fault in an instantaneous manner.

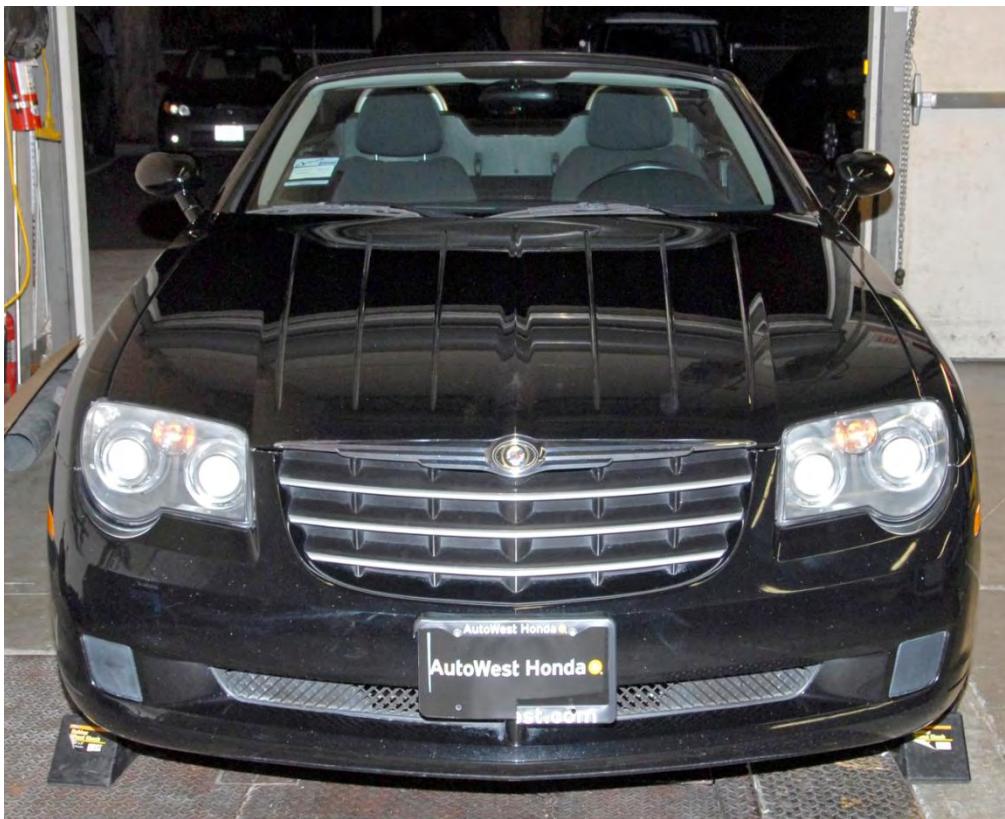
Figure 12. Tested 2005 Chrysler Crossfire.

Dr. Gilbert's fault creation protocol was applied to the 2005 Chrysler Crossfire shown in Figure 12.<sup>18</sup> As with the Avalon and Camry, this involved mechanically creating two sequential electrical faults. Exponent inserted a set of jumper wires between the pedal assembly and the wiring harness connector to the pedal. The jumper wires enabled electrical interconnections between the wires that carry power and position signals between the accelerator pedal and the ECM. Using these jumper wires, the two pedal sensor output wires were connected through a 200-ohm resistor. The resistance value was identical to that used by Dr. Gilbert when he tested his Avalon. To cause an increase in engine speed, Exponent connected a 5-volt power supply wire to the accelerator pedal through a second resistor of 100 ohms.<sup>19</sup> The demonstration on the

2005 Chrysler Crossfire resulted in an apparent “sudden” onset of acceleration and engine revving, similar to that shown in Dr. Gilbert’s demonstration. The apparent “sudden” onset of the acceleration was due to artificially creating the second fault in an instantaneous manner.

During the demonstration, the check engine light did not illuminate. After the demonstration, the vehicle’s computer was checked using an OBD-II tool, and no diagnostic trouble codes were set. Exponent obtained the same results as those shown by Dr. Gilbert in the ABC News video but with a 2005 Chrysler Crossfire. Note that this demonstration was produced under highly artificial conditions where multiple mechanically- created electrical faults, specific resistances, and power supplies were wired into the system through external means to simulate depression of the accelerator pedal. If such circuit faults were actually to occur without deliberate circuit manipulation in an operating vehicle, the presence of such faults would certainly leave “fingerprints” as to their presence.

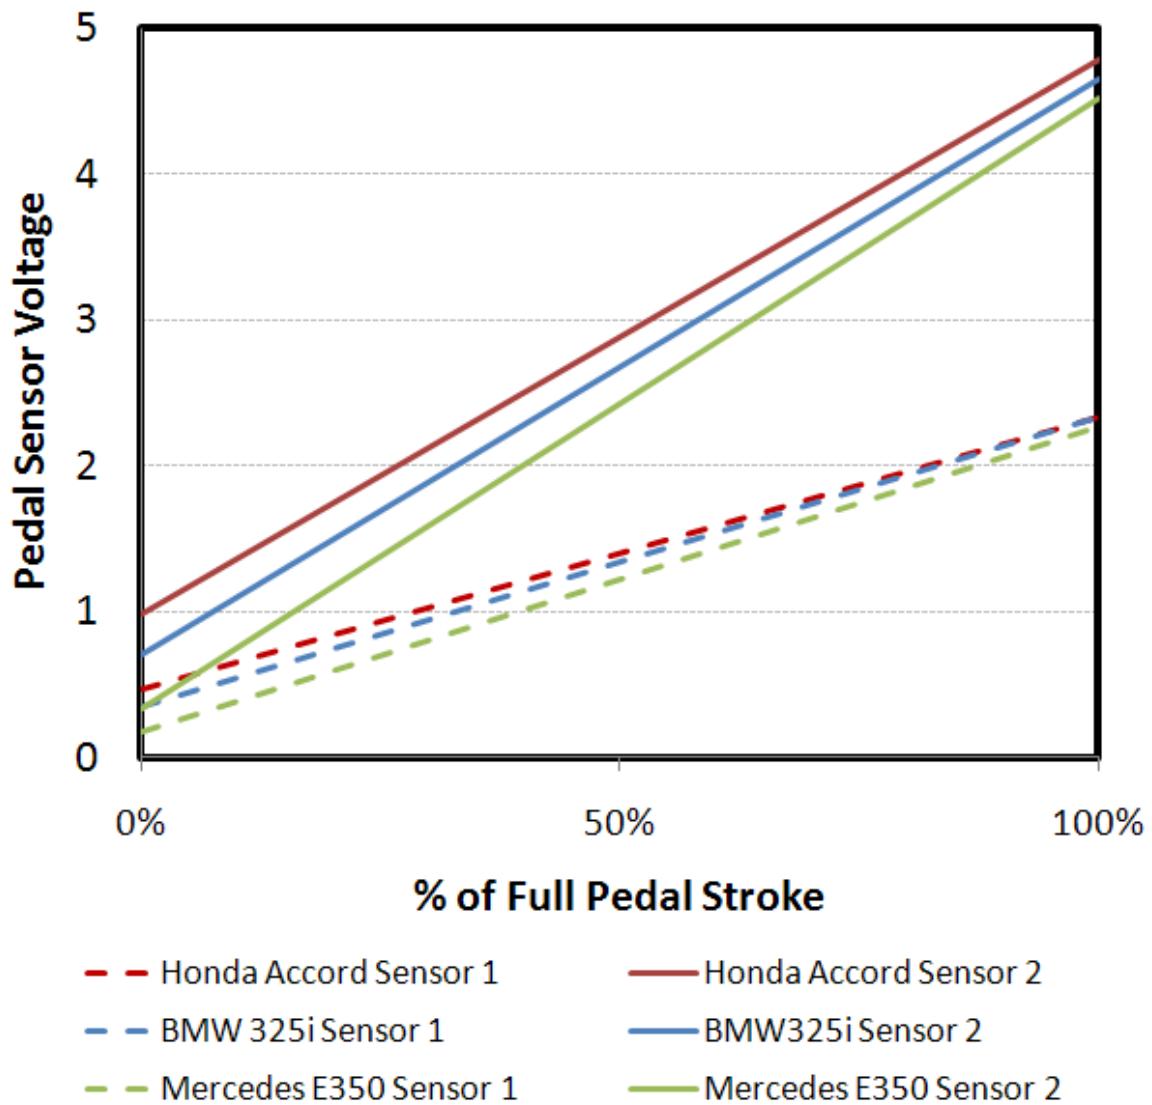
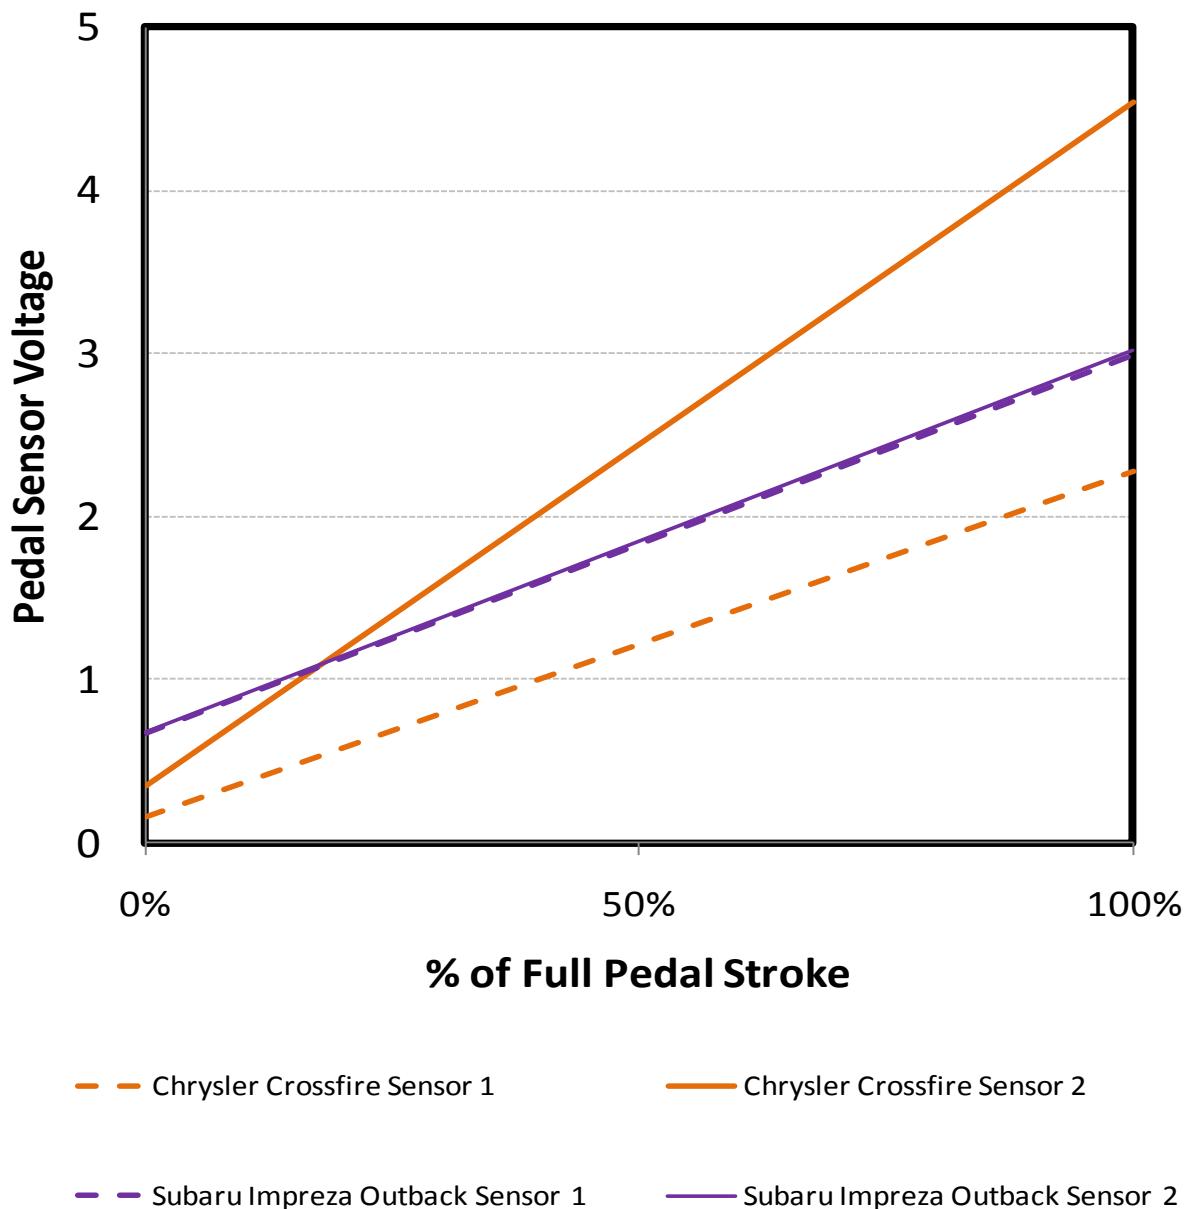
The accelerator pedal sensor output voltages for the 2008 Honda Accord, 2009 Mercedes E350, 2003 BMW 325i, 2005 Chrysler Crossfire, and 2006 Subaru Impreza Outback were measured for different pedal positions. The results of those measurements are shown in Figure 13 and Figure 14. For the Subaru, the two accelerator pedal position sensors produce parallel and nearly identical output voltages. For the other vehicles, the line slopes for sensor 1 and sensor 2 are different and not parallel to each other. Dr. Gilbert opined in his report that several vehicle manufacturers currently use this fault detection strategy and that a short between the two pedal sensor outputs would be detected by the ECM.<sup>20</sup> However, tests with pedal position sensors from five other manufacturers using his strategy demonstrate that the electrical wiring to the pedal can also be manipulated to create an apparent “sudden” onset of acceleration and engine revving.
